# PRELIMINARY RESULTS OF A RECREATIONAL USE ATTAINABILITY ANALYSIS OF ARENOSA CREEK (2453C)

*Dr. Kirk Winemiller*

*Texas AgriLife Research|Extension*

*March 14, 2016*

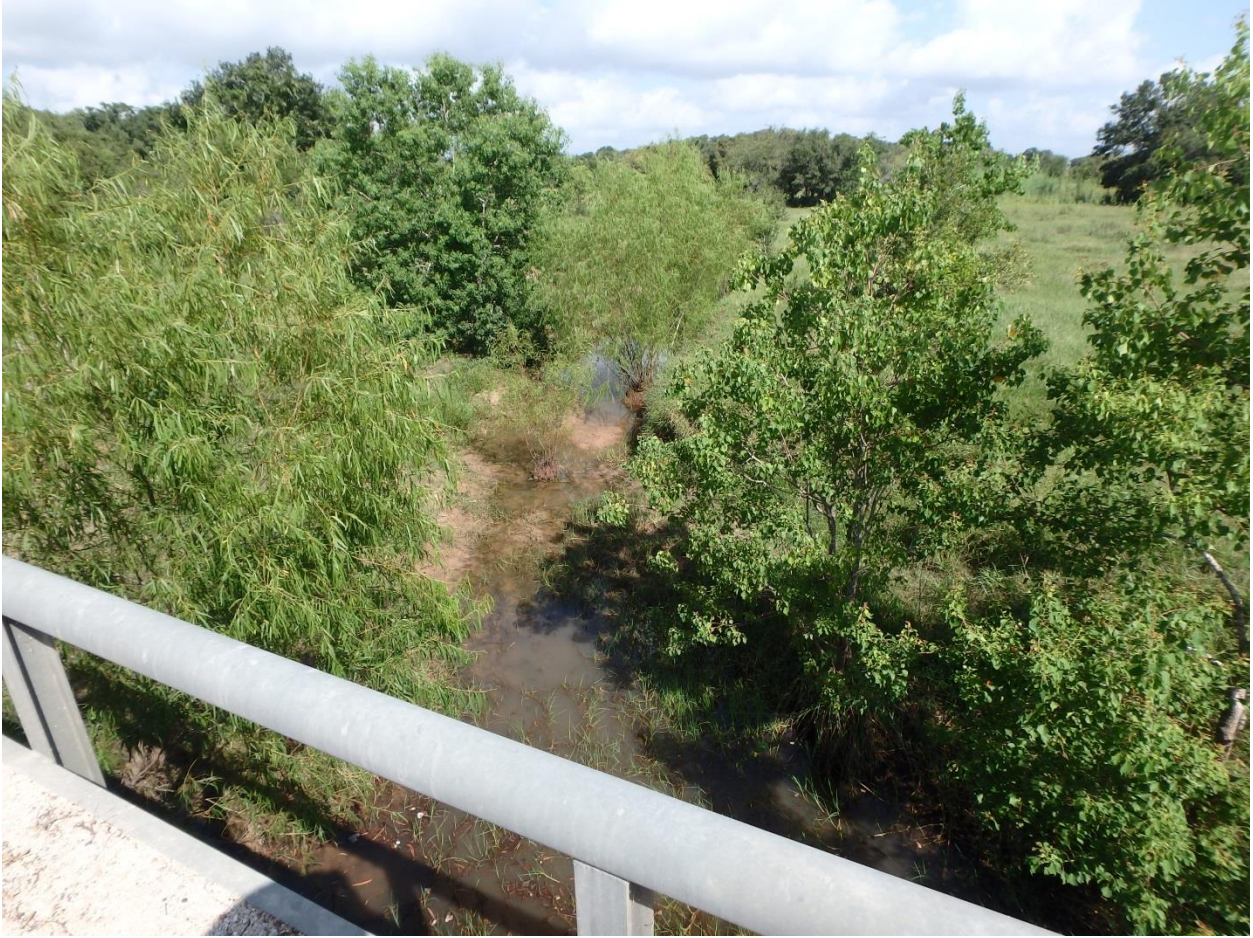
Figure 2. Photograph of Arenosa Creek at RUA survey site 2453C.1 on July 24, 2015.

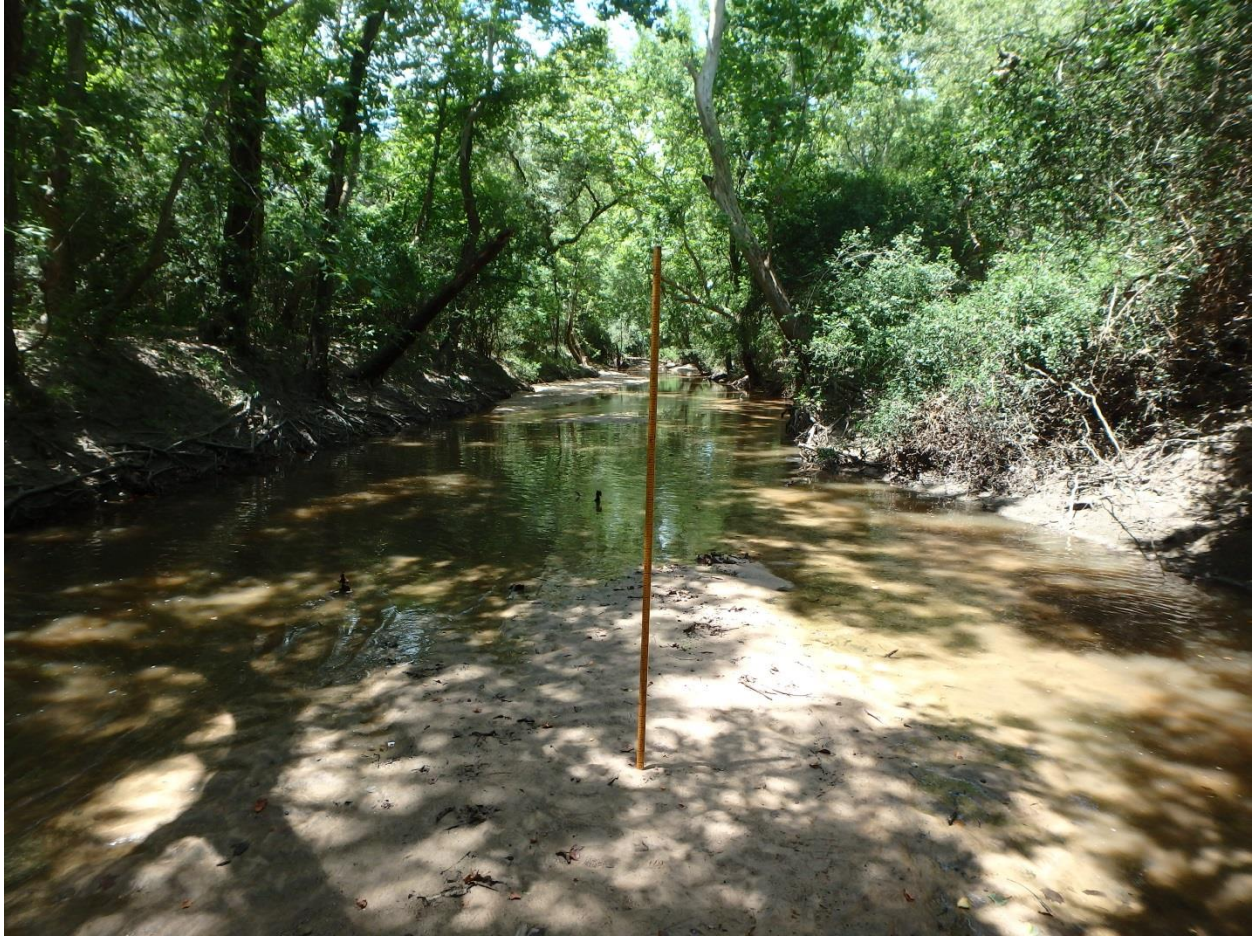
Figure 3. Photograph of Arenosa Creek at RUAA survey site 2453C.10 on July 11, 2015.

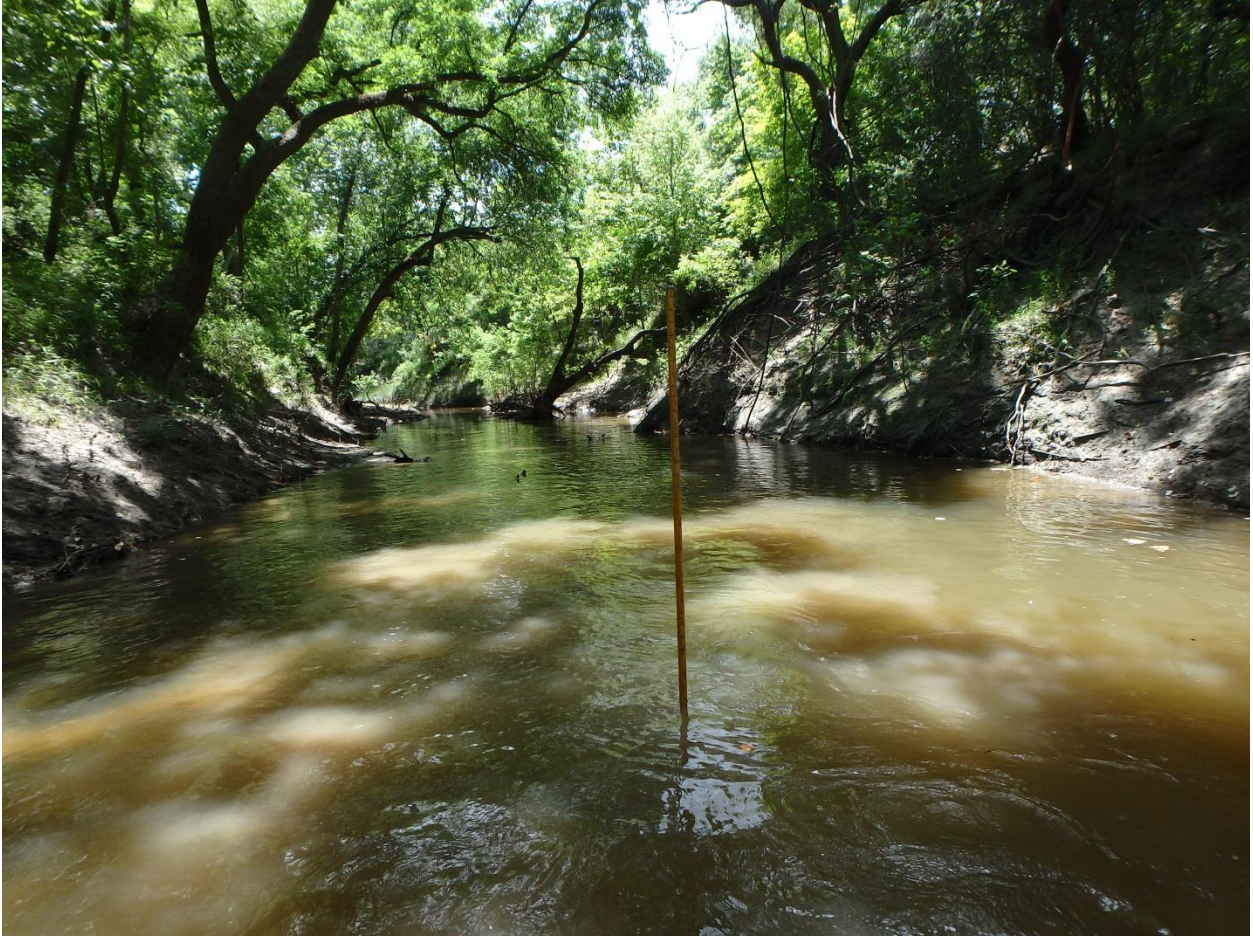
Figure 4. Photograph of Arenosa Creek at RUAA survey site 2453C.23 on July 18, 2015.

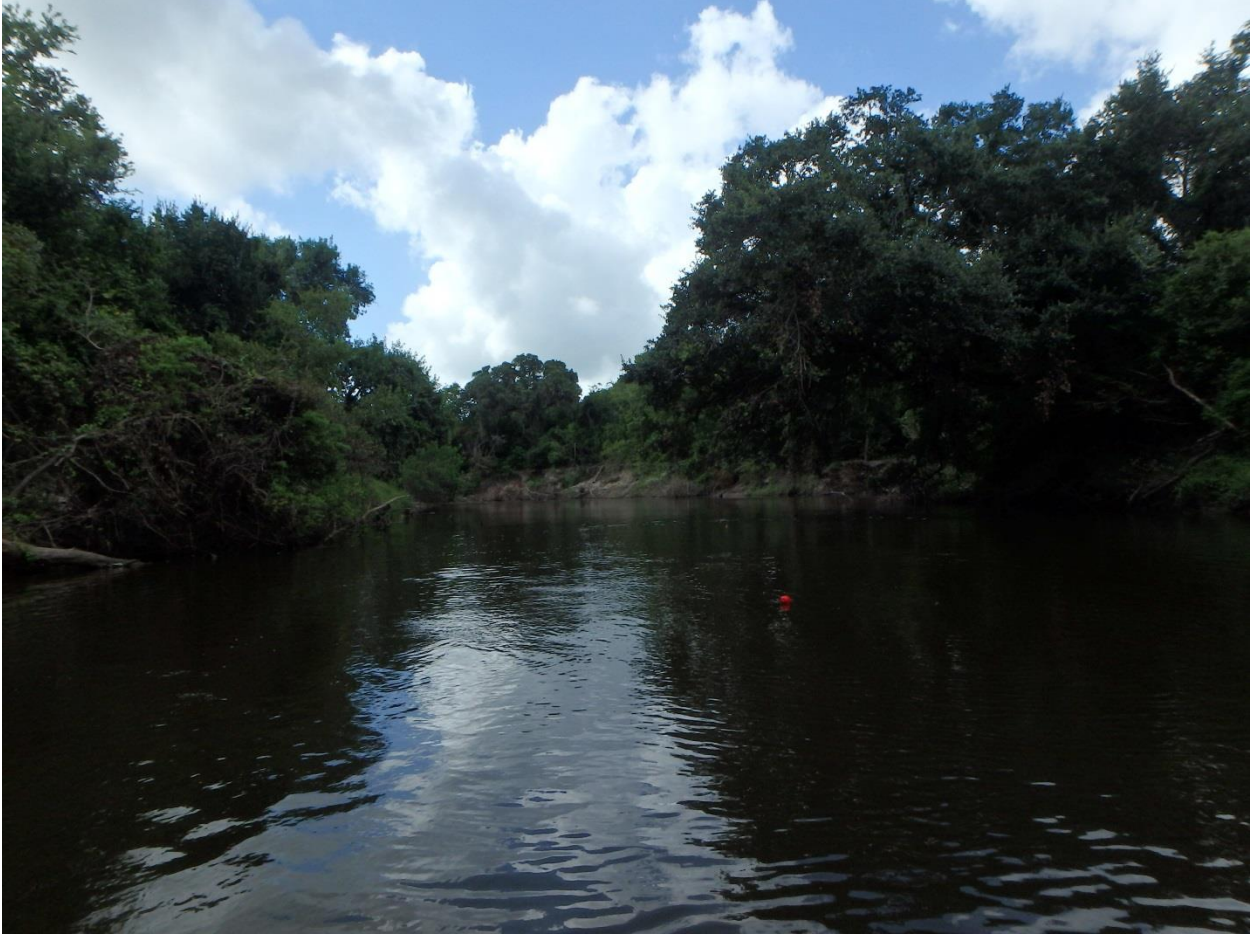
Figure 5. Photograph of Arenosa Creek at RUAA survey site 2453C.Con on July 17, 2015.

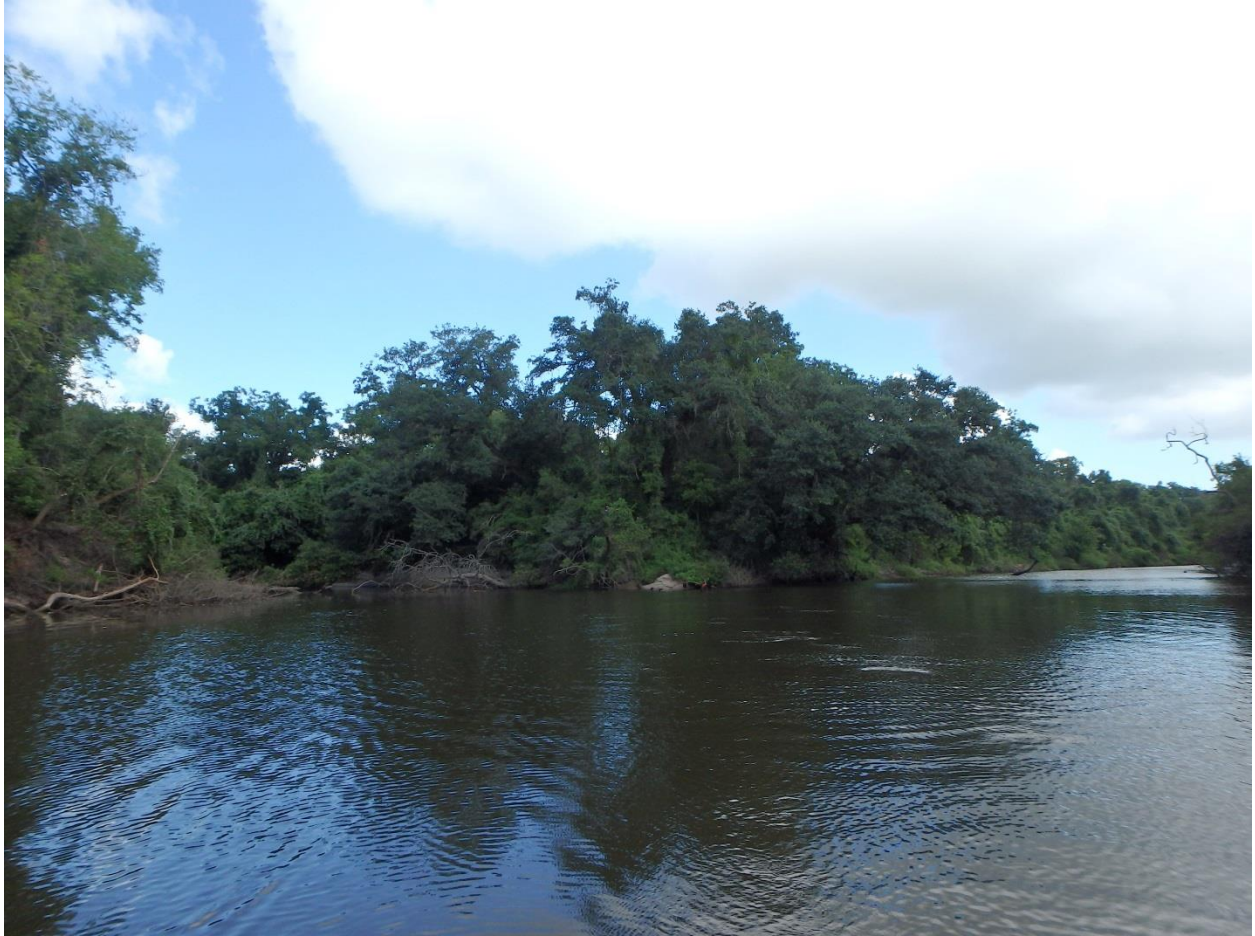
Figure 6. Photograph of the confluence of Arenosa Creek (right side of the photo) and Garcitas Creek (left side of the photo, fallen trees are partially blocking the stream). Photograph was taken down stream of the confluence (on the stream segment named Garcitas Creek Tidal) on July 17, 2015.

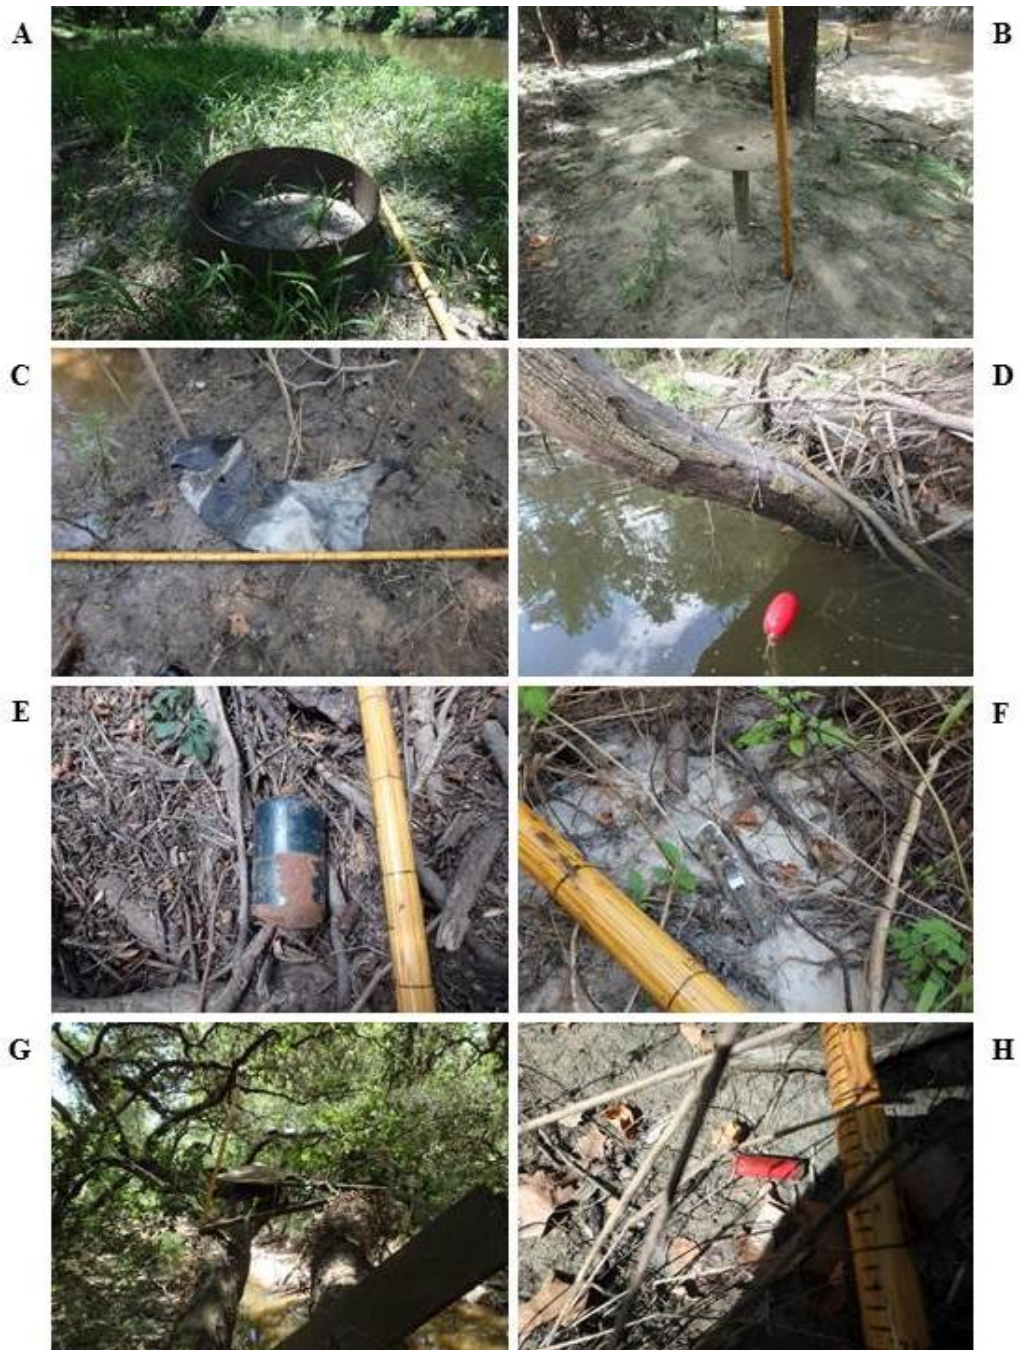
Figure 7. Photographs of indications of human use found on Arenosa Creek. A) Fire pit on the bank. B) Chair next to the stream. C) Part of an inner tube possibly related to primary contact recreation D) Drop line. E) Camping propane tank. F) Pocket knife found on the bank. G) Tree fort/hunting stand over the stream. H) Shotgun shell.

No primary or secondary contact recreational activities were observed on Arenosa Creek during the field surveys conducted in this RUAA project. One indication of human use (IHU) possibly related to primary contact (part of an inner tube) was found at survey site 2453C.14 (at the end of Old Highway Road in Inez, Texas), a well-known location for primary contact (Table 3, Figure 9C, see Primary Contact Recreation Site Found on Arenosa Creek on page 43). This piece of an inner tube; however, could also be related to old tires being dumped into the stream rather than evidence of primary contact recreation. Seven IHUs related to secondary contact I (drop lines) were found at four survey sites (Figure 9D). Seventeen IHUs related to non-contact activities were found including a fire pit next to the stream (Figure 9A), two chairs next to the stream (Figure 9B), a propane tank (Figure 9E), a pocket knife next to the water (Figure 9F), a tree fort/hunting stand over the water (Figure 9G) and two shotgun shells (Figure 9H).

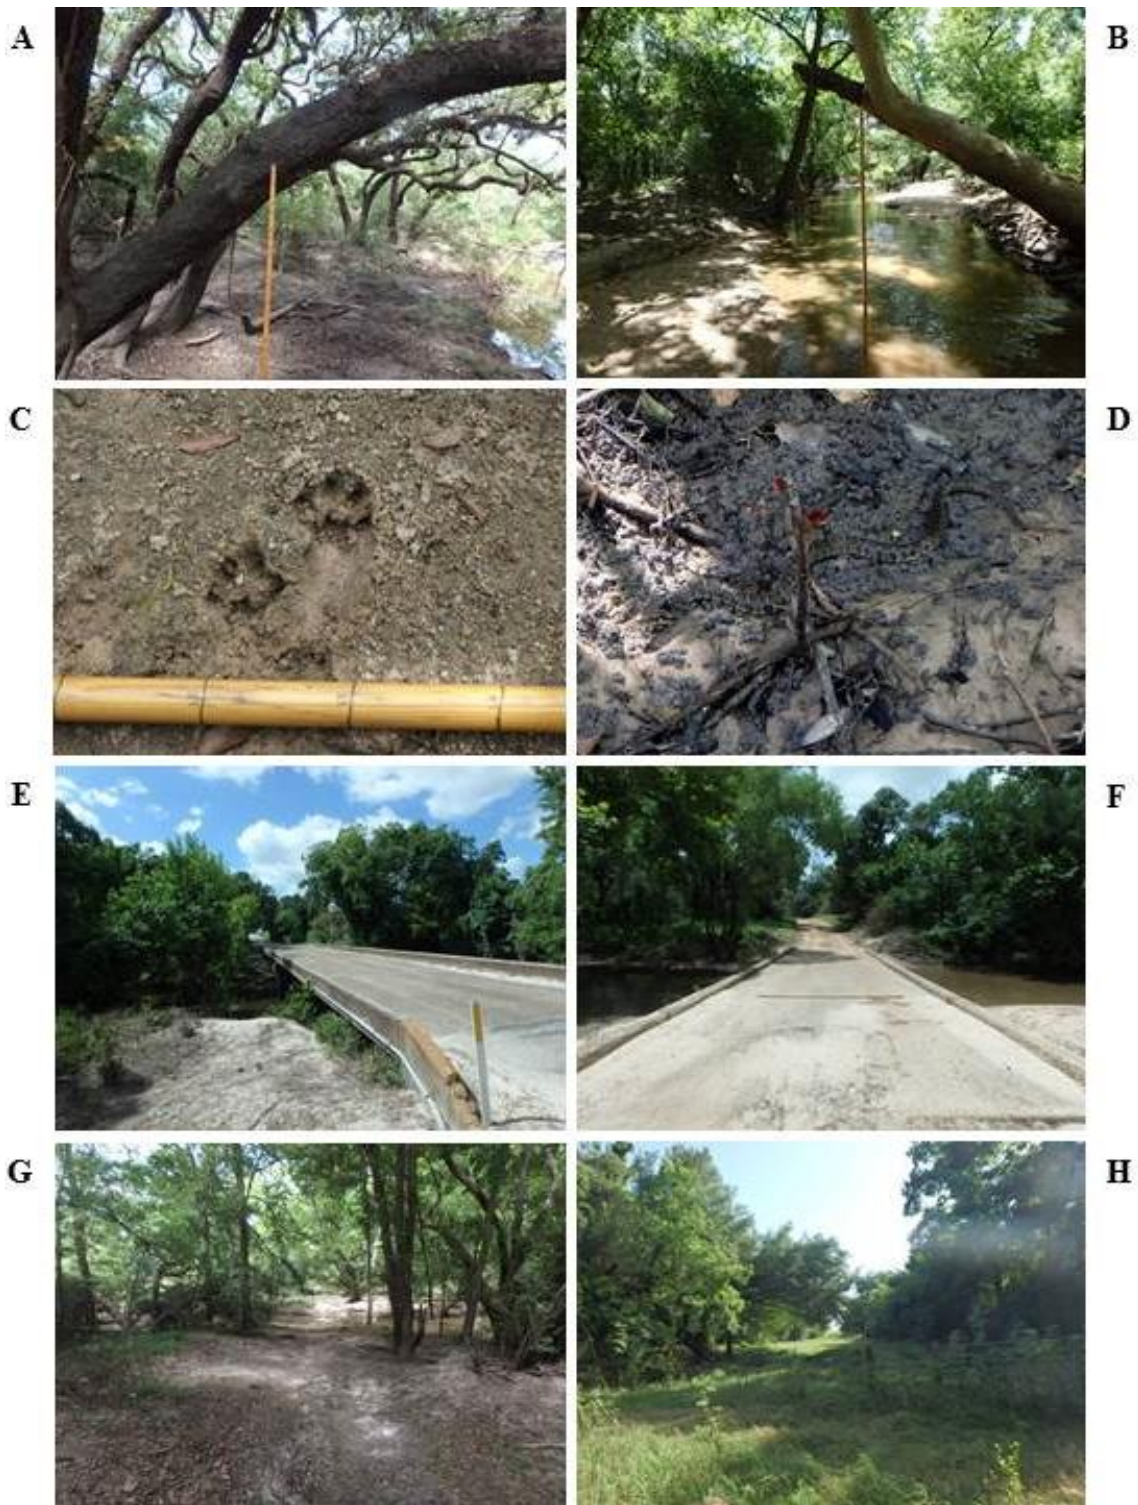
Figure 8. Factors that promote recreation on Arenosa Creek. A-B) Natural and scenic riparian corridor and stream. C-D) Wildlife (Bobcat tracks and water snake). E-F) Bridges providing access. G) Maintained road/trail leading up to the stream. H) Utility corridor crossing the stream.

Seventy one surrounding conditions that promote recreation were recorded during surveys on Arenosa Creek (Table 4). Scenic natural surroundings (15, Figure 10A and 10B) were recorded as the most frequent surrounding condition that promotes recreation followed by wildlife and wildlife evidence (14, Figure 10C and 10D), rural area (14), the presence of fish (5), bridge crossings (5, Figure 10E and 10F) and utility corridors that could improve access to the stream (4, Figure 10H). Other surrounding conditions that promote recreation include deep water, water that appears clean, boat access from boat ramps downstream, gently sloping banks, and a maintained road/trail going up to the stream (Figure 10G).
